# Manhole Inspection Summary

Manhole # S29E\_\_009MH

Insp Date: **10/24/07 4:57 PM**

**Location** Address: **725 SARATOGA ST**

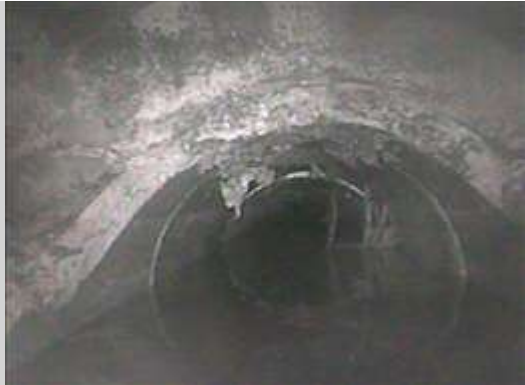
12 O'Clock Outflow

18 in. Circular Gravity Sewer  
Pipe Out @ 12 O'Clock

Pipe Height: (in.) Direct  
Pipe Material: **Clay** ☐ Pipe Lined  
Invert Depth: **10.62** (ft.) Flow Characteristics: **Slow**  
Deposits: ☐ None ☐ **Mud** ☐ **Grassy** ☐ Debris ☒ **Grease**  
Silt Depth: **5** (in.) Deposits Extent: **Light**  
Infiltration: **Evidence** Pipe Seal Cond: **Sound**

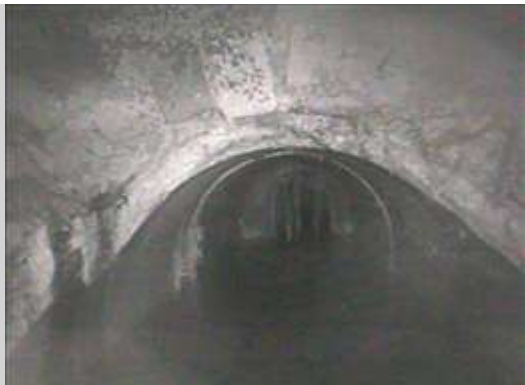
6 O'Clock Inflow

18 in. Circular Gravity Sewer  
Pipe In @ 6 O'Clock

Pipe Height: (in.) Direct  
Pipe Material: **Clay** ☐ Pipe Lined  
Invert Depth: **10.58** (ft.) Flow Characteristics: **Slow**  
Deposits: ☐ None ☐ **Mud** ☐ **Grassy** ☐ Debris ☒ **Grease**  
Silt Depth: **4** (in.) Deposits Extent: **Light**  
Infiltration: **Evidence** Pipe Seal Cond: **Sound**

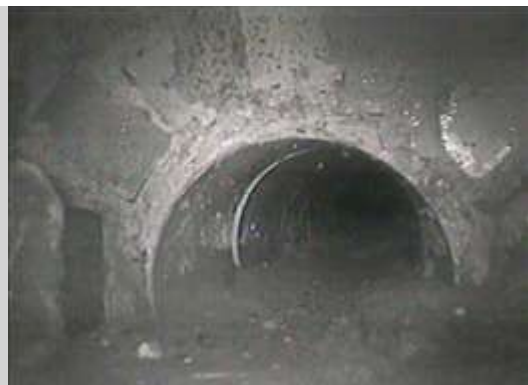
9 O'Clock Inflow

6 in. Circular Gravity Sewer  
Pipe In @ 9 O'Clock

Deposits: ☐ None ☒ **Mud** ☒ **Sludge** ☐ Debris ☐ Grease

Silt Depth: **2** (in.) Deposits Extent: **Medium**
